Manhole Inspection Summary

Manhole # **S43KK_024MH**

Insp Date: **1/8/08 12:33 PM**

Location Address: **1832 BROADWAY**

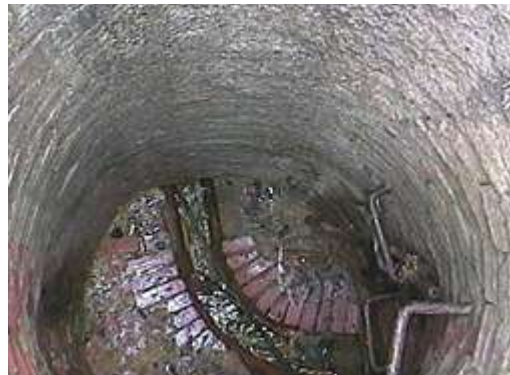
Defect 1

Count: **4** Missing: **1** ☒ **Corroded**

STEPS CORRODED

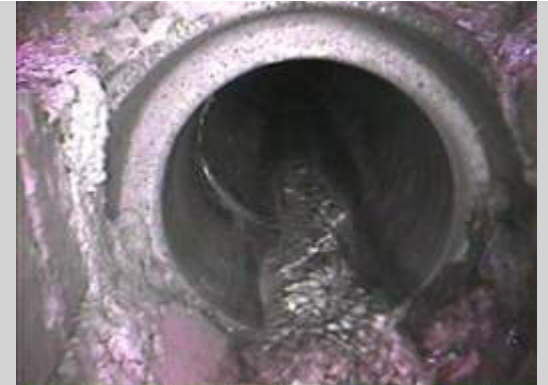
12 O'Clock Outflow

8 in. Circular Gravity Sewer
Pipe Out @ 12 O'Clock

Pipe Height: (in.) Direct
Pipe Material: **Clay** ☐ Pipe Lined
Invert Depth: **9.06** (ft.) Flow Characteristics: **Fast**
Deposits: ☒ None ☐ Mud ☐ Sludge ☐ Debris ☐ Grease
Silt Depth: (in.) Deposits Extent:
Infiltration: **None** Pipe Seal Cond: **Sound**

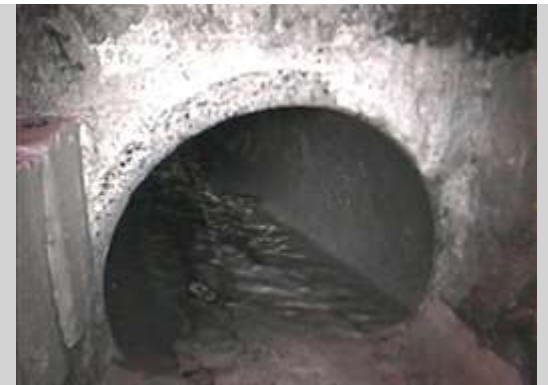
3 O'Clock Inflow

8 in. Circular Gravity Sewer
Pipe In @ 3 O'Clock

Pipe Height: (in.) Direct
Pipe Material: **Clay** ☐ Pipe Lined
Invert Depth: **9.04** (ft.) Flow Characteristics: **Fast**
Deposits: ☒ None ☐ Mud ☐ Sludge ☐ Debris ☐ Grease
Silt Depth: (in.) Deposits Extent:
Infiltration: **None** Pipe Seal Cond: **Sound**

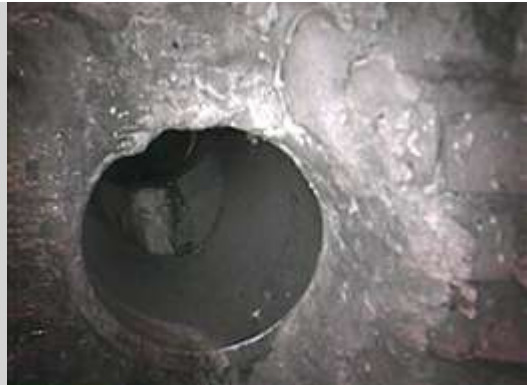
4 O'Clock Inflow

6 in. Circular Gravity Sewer

Pipe In @ 4 O'Clock

Pipe Height: (in.) Direct

Pipe Material: **Clay** ☐ Pipe Lined

Invert Depth: **5.86** (ft.) Flow Characteristics: **None**

Infiltration: **None**

Pipe Seal Cond: **Sound**

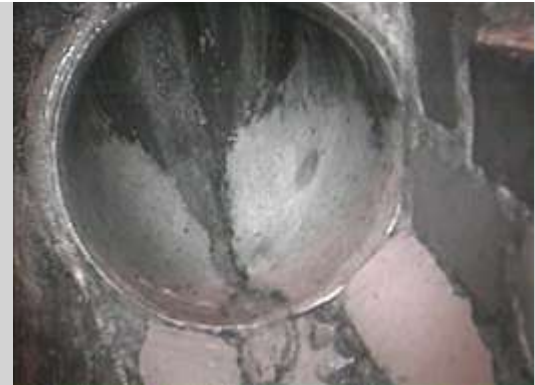
Drop In @ 4 O'Clock

Drop: **Outside Direct**

Inv Depth: **8.76** (ft.)

Drop Condition: **Open**
